REPORT NO: NAWCADPAX/RTR-2000/97

S-3B SMALL-SCALE APPLIQUÉ COUPON FLIGHT TEST EVALUATION RESULTS

9 January 2001

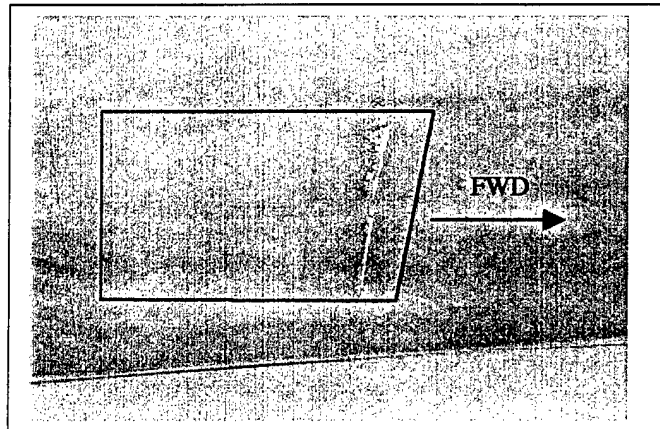
Following the failure mode test flight, the prepeeled coupons at site 1 were inspected. Figure 8 shows the prepeeled coupons at site 1 on the left wing following the flight, and figure 9 shows the prepeeled coupons at site 1 on the right wing following the flight. Neither the FP500 nor FP1500 material experienced any additional peeling, and the film tattered as desired.

Figure 8: Prepeeled coupons at site 1 on left wing following flight. (Test site outlined in black.)

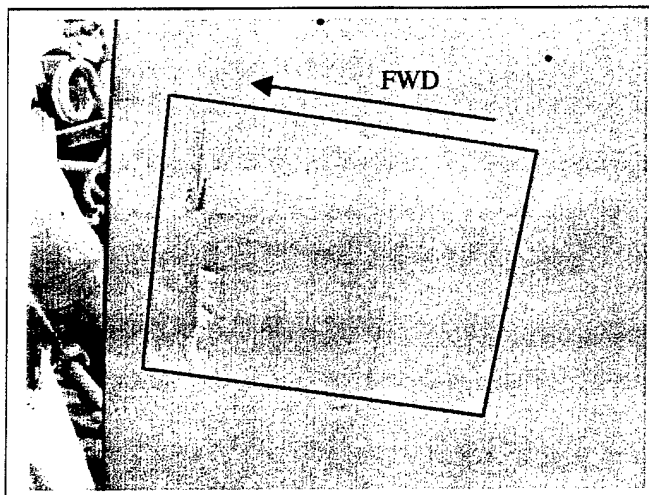
22. The leading edge of the two forward-most coupons was peeled back at site 2 on the left and right lower gear doors. Figure 10 shows the prepeeled coupons at site 2 on the left door prior to flight, and figure 11 shows the prepeeled coupons at site 2 on the right door prior to flight.

Figure 10: Prepeeled coupons at site 2 on the left lower gear door prior to the flight. (Test site outlined in black)

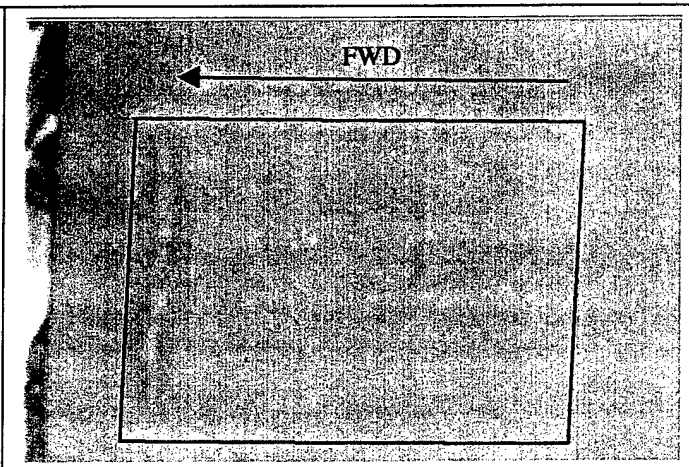
Following the failure mode test flight, the prepeeled coupons at site 2 were inspected. Figure 12 shows the prepeeled coupons at site 2 on the left lower gear door following the flight, and figure 13 shows the prepeeled coupons at site 2 on the right lower gear door following the flight. Neither the FP500 nor FP1500 material experienced any additional peeling, and the film tattered as desired.

Figure 13: Prepeeled coupons at site 2 on the right lower gear door following the flight. (Test site outlined in black.)

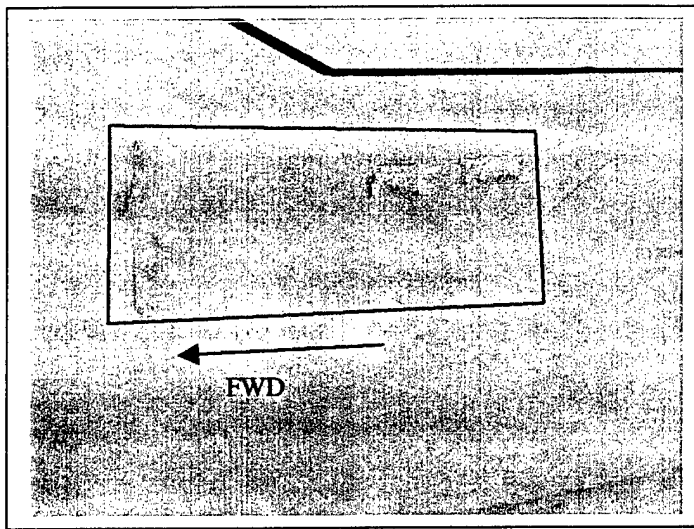
23. The leading edge of the two forward-most coupons, and the upper edge of the upper-most aft coupons were peeled back below the rudder. Figure 14 shows the prepeeled coupons at site 3 below the rudder prior to flight.

Figure 14: Prepeeled coupons at site 3 on the vertical tail below the rudder prior to flight.

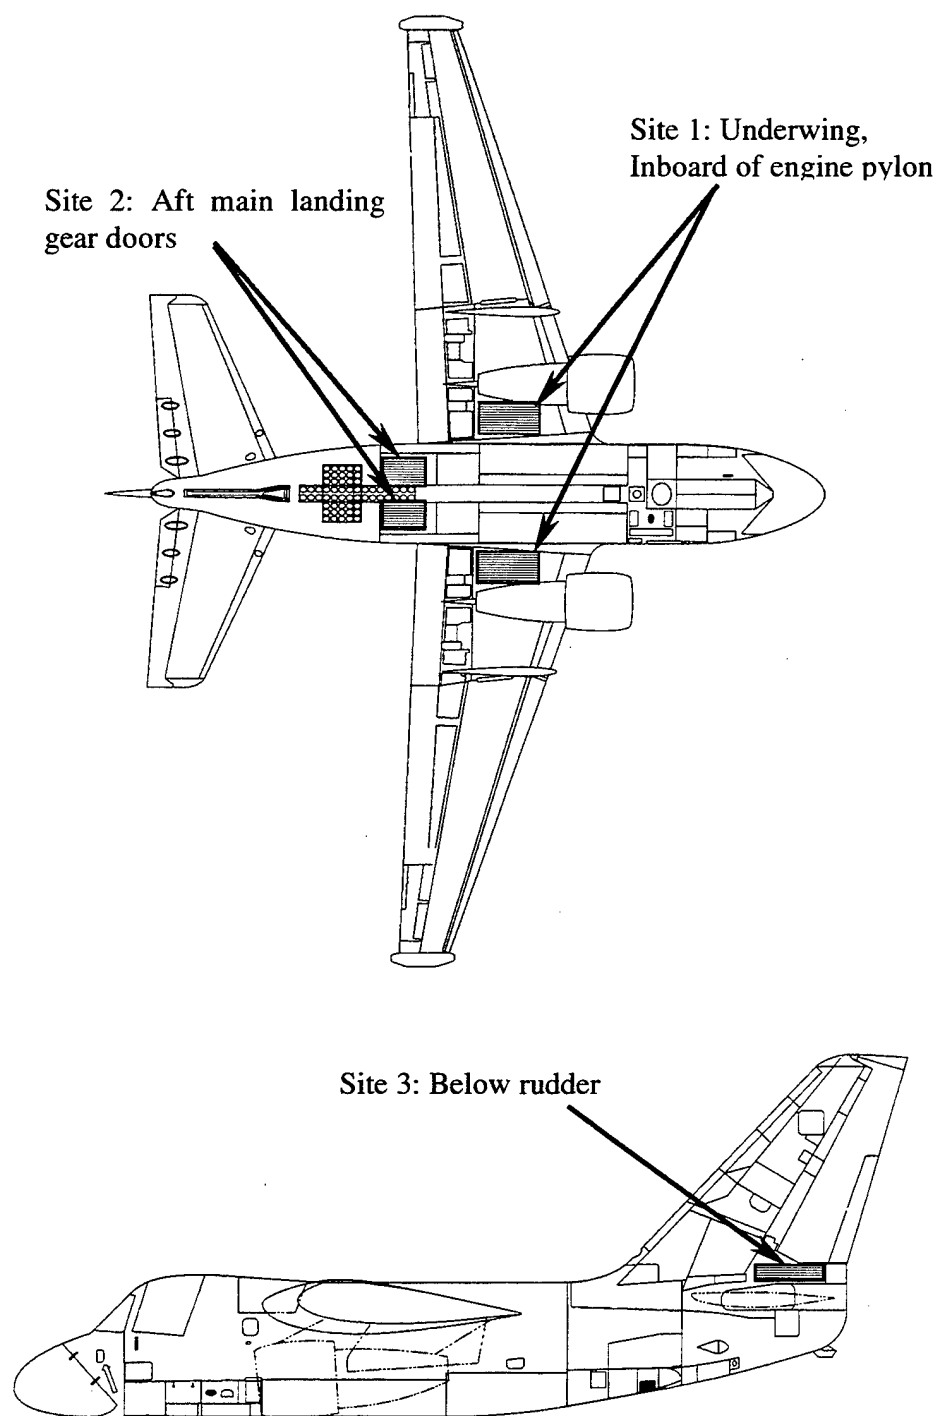
Figure B-1: Coupon Test Site Locations

16. The appliqué material, FP500 and FP1500 with 52-4 adhesive, was applied to the three sites. The coupon test sites are listed in table A-2 and shown in figure B-1. They were first painted with self-priming topcoat (TT-P-2756), "Unicoat," and allowed to dry at least 2 weeks before the appliqué material was applied. Scotch-brite™ pads, isopropyl alcohol, and cheesecloth were used to clean the surface at each test site. The average surface roughness was obtained by taking the average of six to nine readings. The average 180 deg peel adhesion, for both the 5 min dwell and the extended dwell, were obtained by taking the average of 8 readings at 12 in./min using a pull scale on 1 x 8 in. strips of appliqué. The results of the surface roughness measurements and 180 deg peel adhesion measurements can be found in figure B-2.

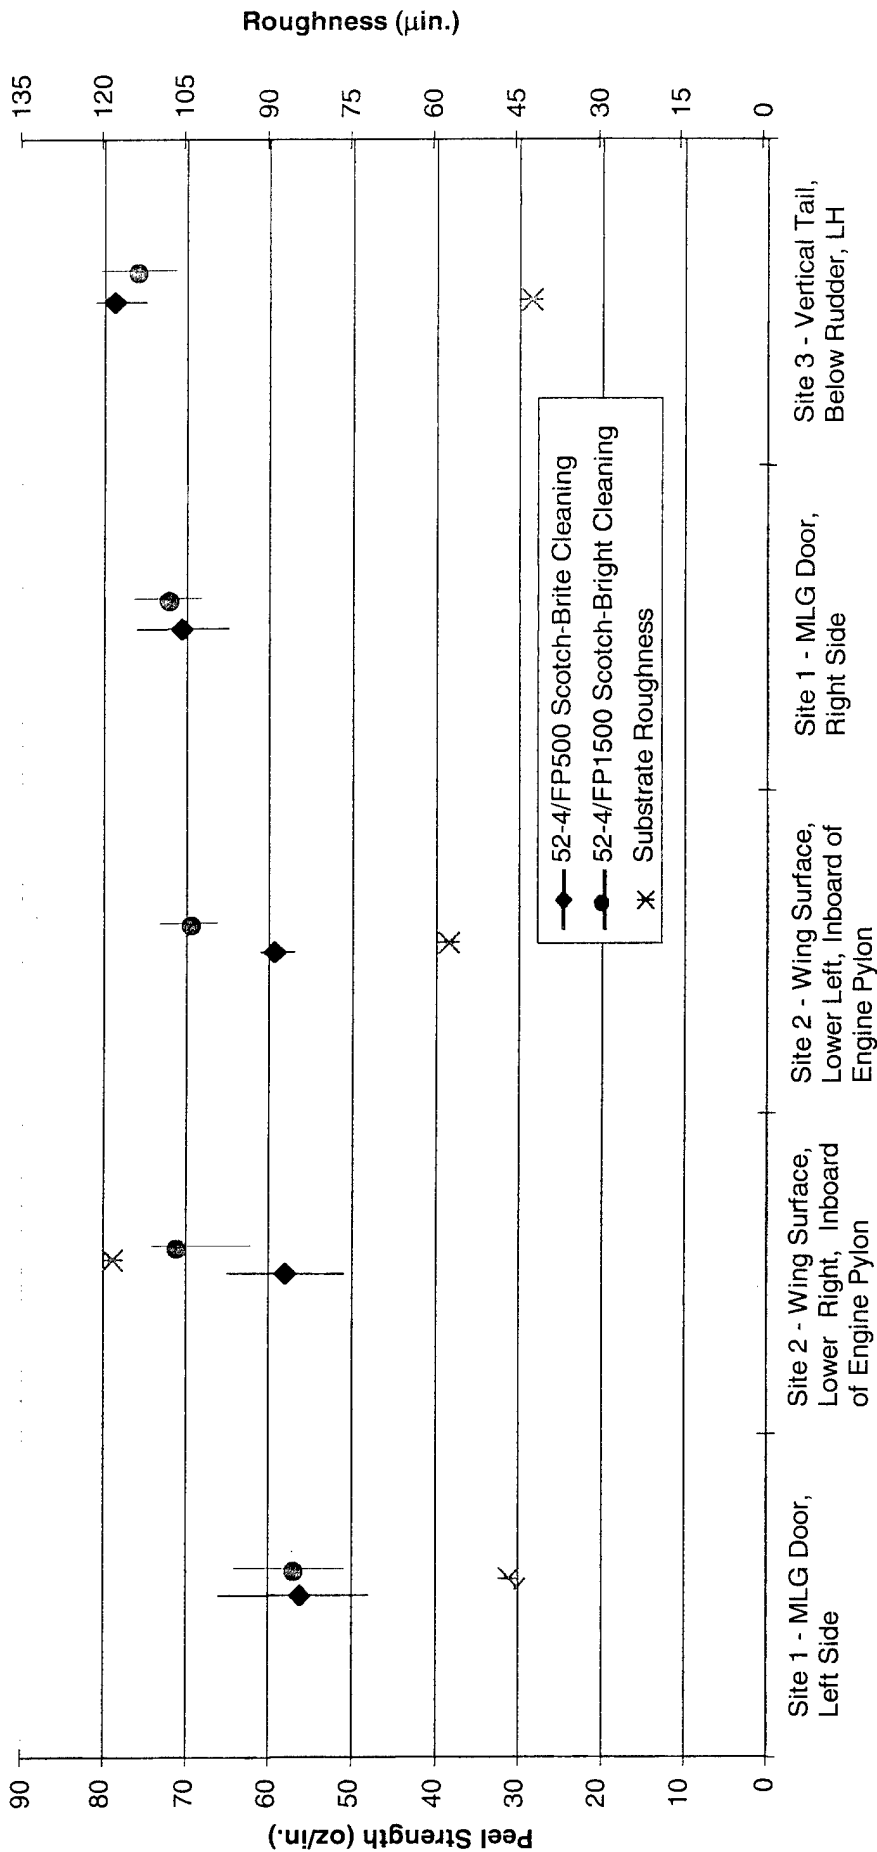
Figure B-2: Surface Characterization and Peel Strengths

Peel Data on BuNo 160607
 TT-P-2756 Substrate
 Cleaned with Scotch-Bright and Isopropyl Alcohol
